Minerals Inspection Report

Mine Name: Nielson Limestone Mine	Permit Number: S/49/0052	Mine Status: Active
Operator Name: Nielson Construction	Inspection Date: 8/23/2016	Permit Fees: Paid
Inspector(s): A. Abate	Inspection Time: 10:30 AM	Bond Amount: \$55,100
Attendee(s): Wayne McCandless, Operator	Weather: Clear 80s	Bond Escalation: 9/7/2015
Inspection Purpose: Routine Inspection		Prior Inspection:

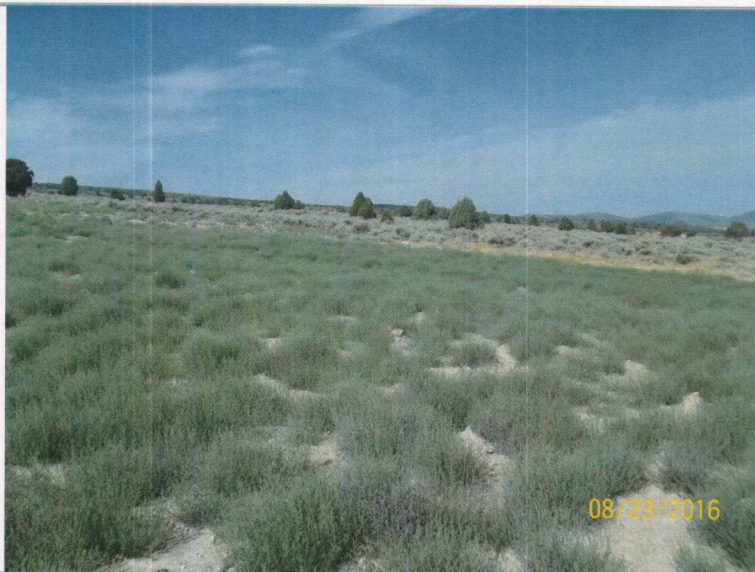
6. <i>Reclamation</i>	<input checked="" type="checkbox"/>	<input type="checkbox"/>
West side of mine has been ripped and seeded in the fall of 2015. The three acres that were reclaimed on the west side of the permit area was completely covered in Russian Thistle. Although this is not ideal, Russian thistle acts as a nurse crop to control erosion and will eventually die off allowing the native vegetation in the seed mix to take hold.

Western portion of the mine dominated by Russian Thistle

9. <i>Revegetation</i>	<input checked="" type="checkbox"/>	<input type="checkbox"/>
Continue to monitor the revegetation efforts for the west side reclaimed area to determine if the Russian Thistle has died off.

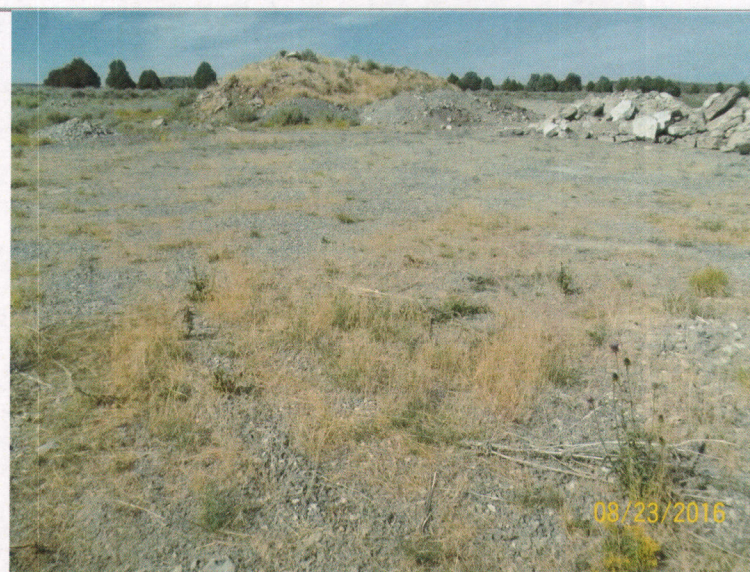
Nielson is interested in keeping the permit under 10 acres as a small mine. The operator has recently had the site sprayed for noxious weeds to control the amount of musk thistle on the mine property. Weed control appears to be effective with only very minor amounts of musk thistle present on the permit area. Will continue to monitor the revegetation efforts for the west side reclaimed area to determine if the Russian Thistle has died off.

Minor amounts of musk thistle were observed.

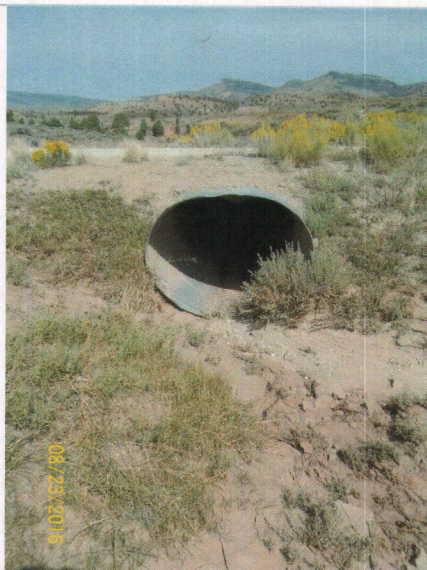
2. <i>Public Safety (shafts, adits, trash, signs, highwalls)</i>	<input type="checkbox"/>	<input type="checkbox"/>
3. <i>Protection of Drainages/Erosion Control</i>	<input checked="" type="checkbox"/>	<input type="checkbox"/>
Culvert near the gate was inspected. A small amount of sediment was spilling out on the west side but otherwise it was clear and water could easily pass through.

Culvert near the entrance was clear.

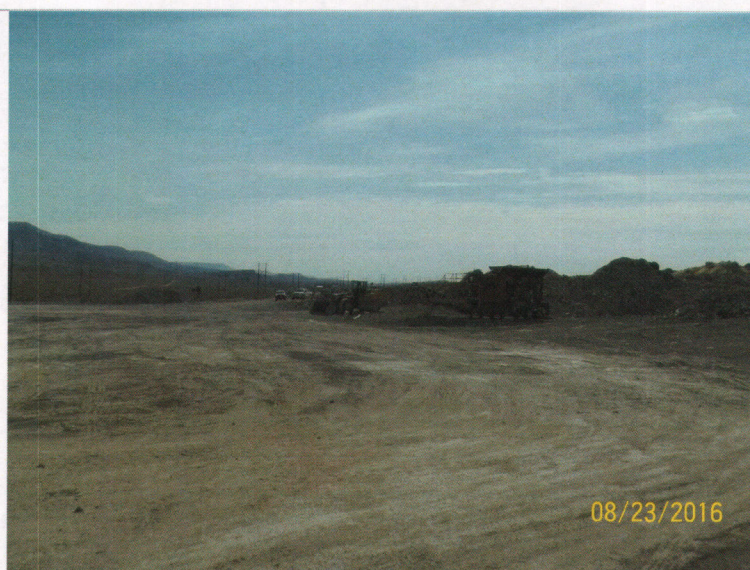
Overview of the mine site looking east.

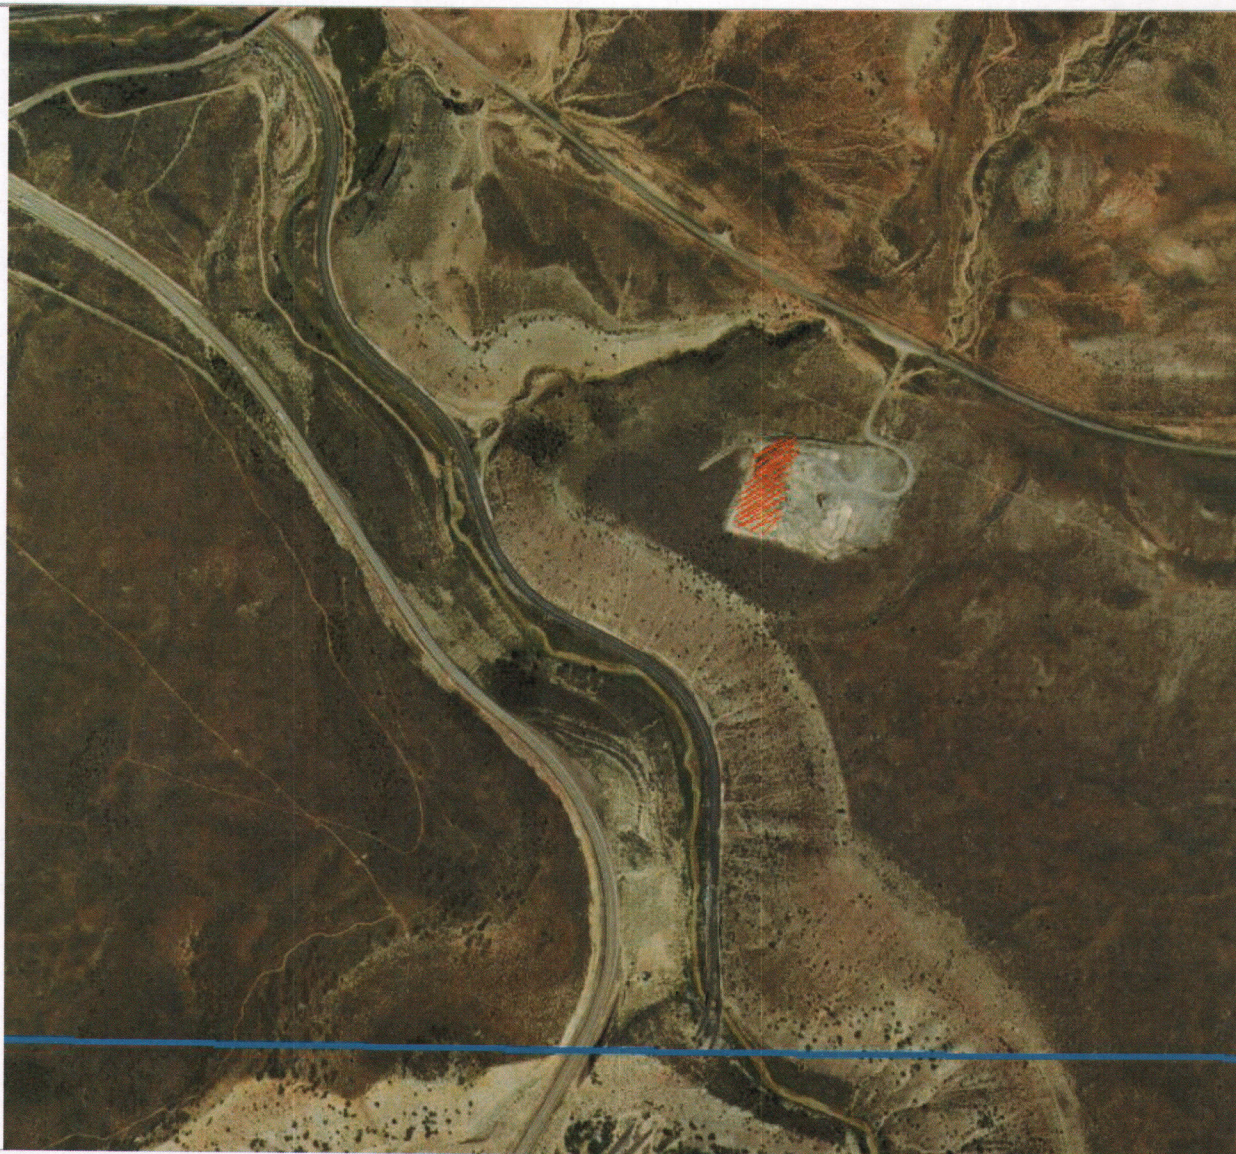
Nielson Limestone Pit located off Emma Park Road off of Highway 6 along the Utah/Carbon County border. The western portion of the permit area was ripped and seeded in 2015 to keep the permit under 10 acres.
